THREE RIVERS PARK LANDSCAPE MANAGEMENT GUIDELINES

DECEMBER 2006

ANDROPOGON ASSOCIATES LTD.
CIVIL AND ENVIRONMENTAL CONSULTANTS, INC.
RIVERLIFE TASK FORCE

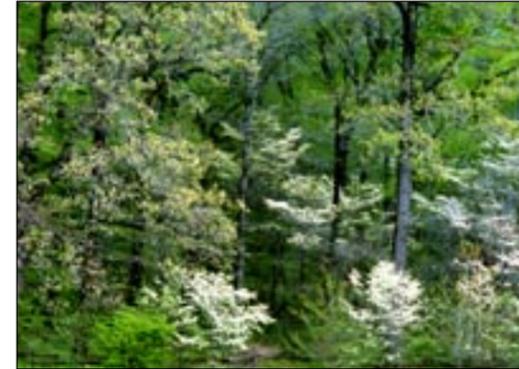
forest: continuous canopy with layers

plant wherever possible; provides shade, recreation, riparian habitat, stormwater and erosion control, flood mitigation and water quality treatment

balled and burlapped
containers
bare root

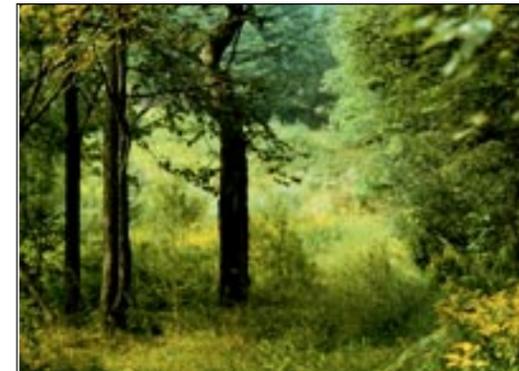
woodland: open canopy with tall grasses

plant wherever views are desired through trees; provides most benefits of forest and may be more acceptable in developed areas

balled and burlapped
containers
bare root

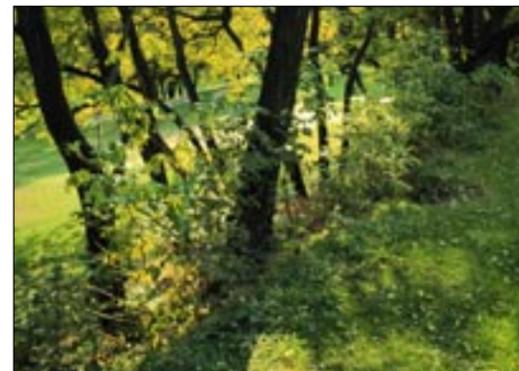
shrub buffer: mixed species of varying heights

plant in masses or as a hedgrow to protect steep slopes and as natural fences for pedestrian/bicycle traffic control

containers
brush layers
live stakes

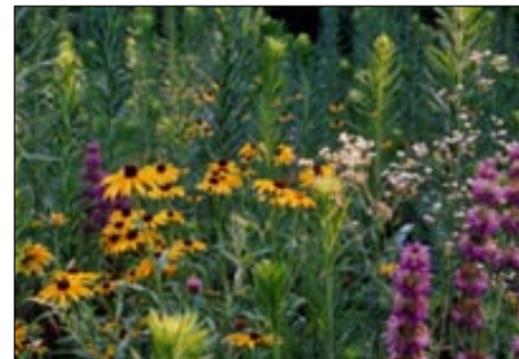
meadow: warm season grasses and wildflowers

plant as a means of managing large open areas; provides riparian buffers & habitat for small mammals, insects and birds

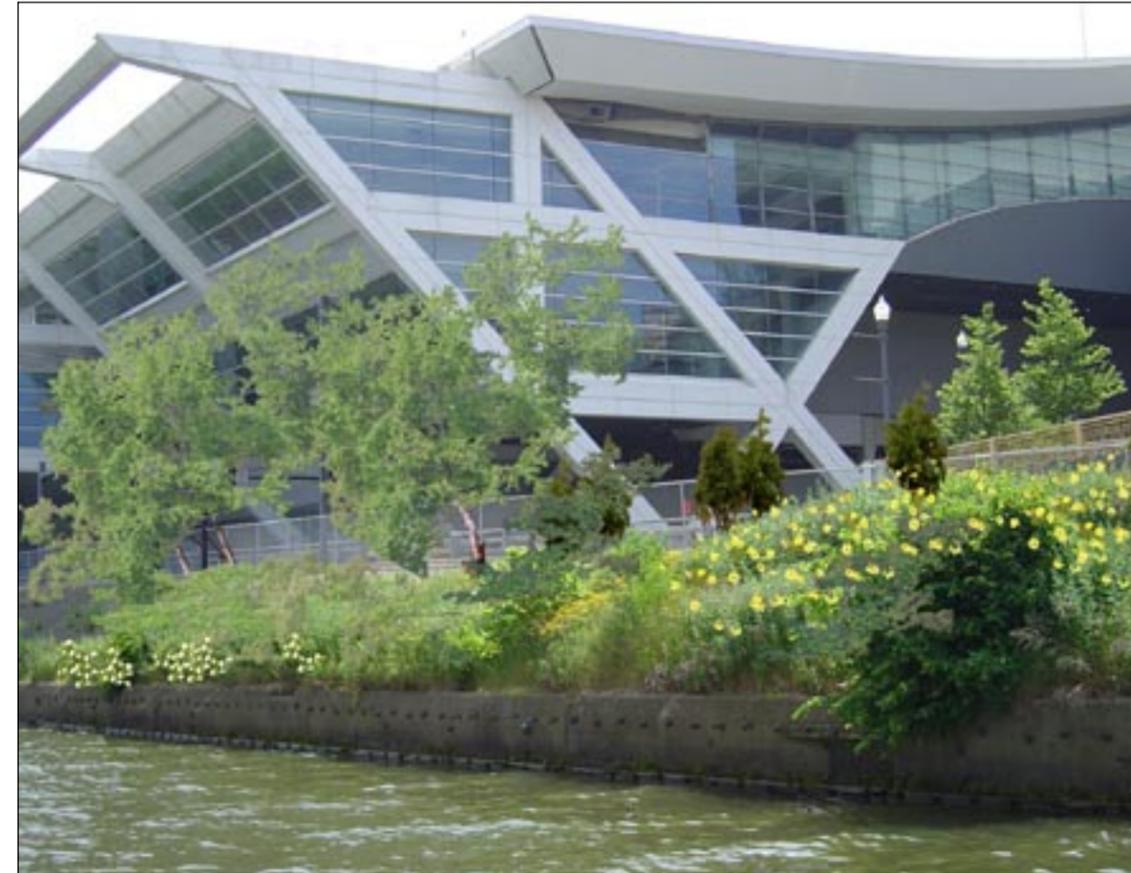
FIGURE 2. Convention Center example illustrates river edge planting of canopy trees and gold flowering perennials

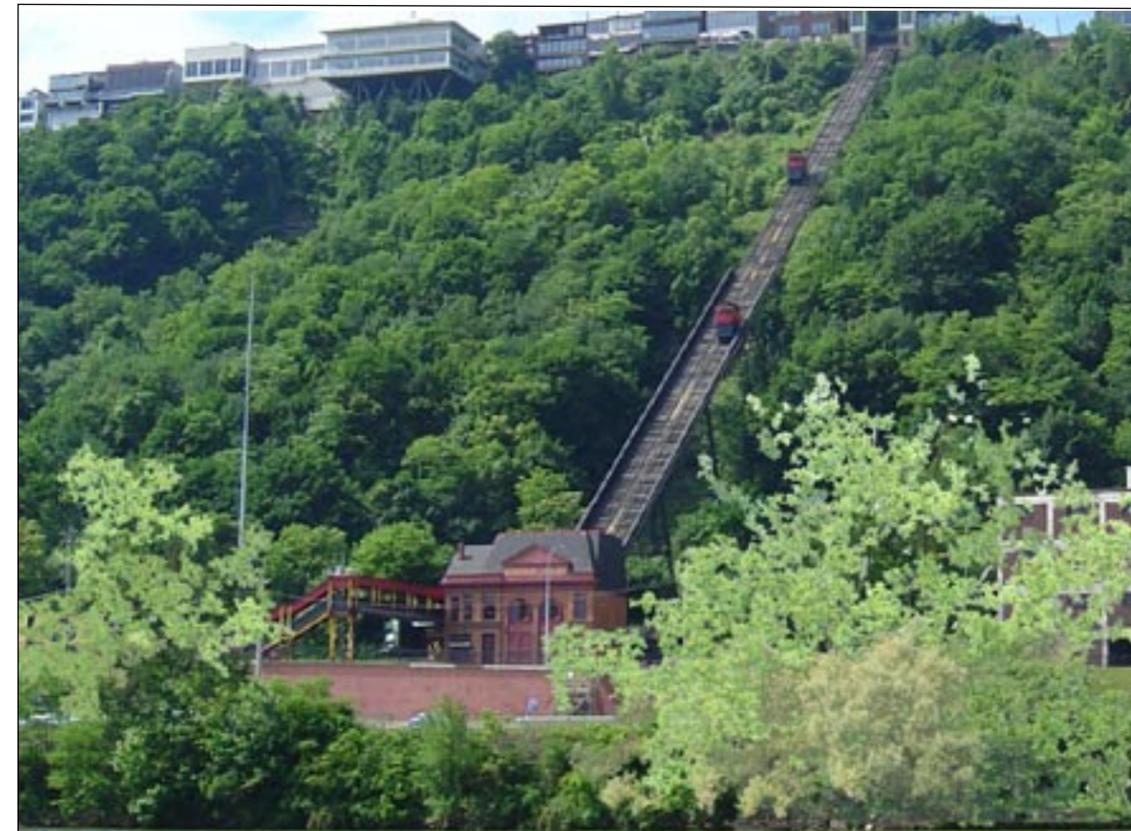
FIGURE 3. Duquesne Incline example illustrates sycamore planting at river edge
Photographs and digital enhancements, Andropogon.

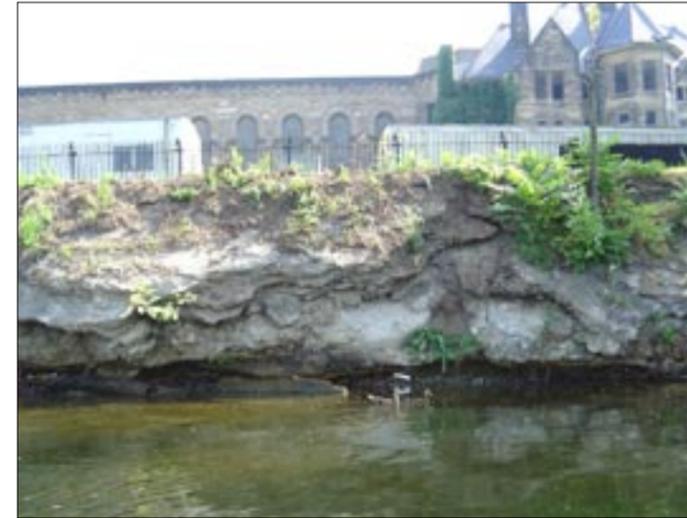
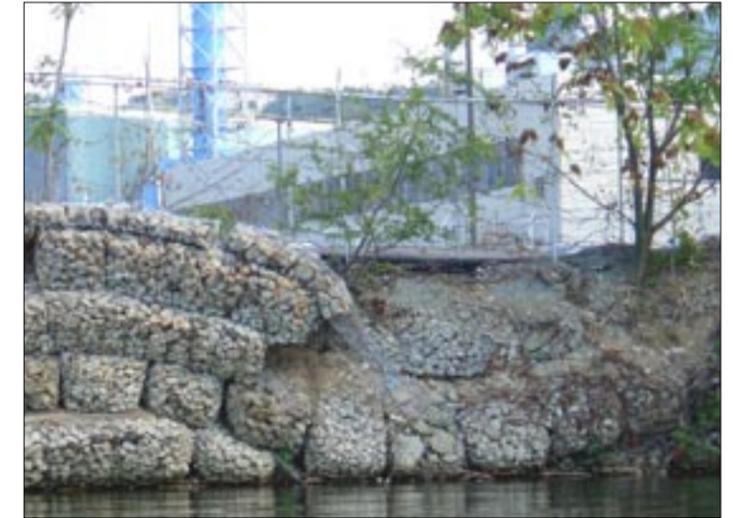
Photos of existing conditions at Western Penitentiary show deteriorated gabion wall

This section of Ohio River edge is formed of mostly slag, resulting in a near vertical face of compressed material that – due to its manufactured nature – is subject to crumbling and erosion. Part of the edge has been reinforced with gabions – stones enclosed with wire mesh. The lower tiers of gabions have begun to fail – reconstruction of this edge is unavoidable. There are several alternative methods for restoring the edge – all involve significant earth moving and construction of a vegetated, reinforced edge.

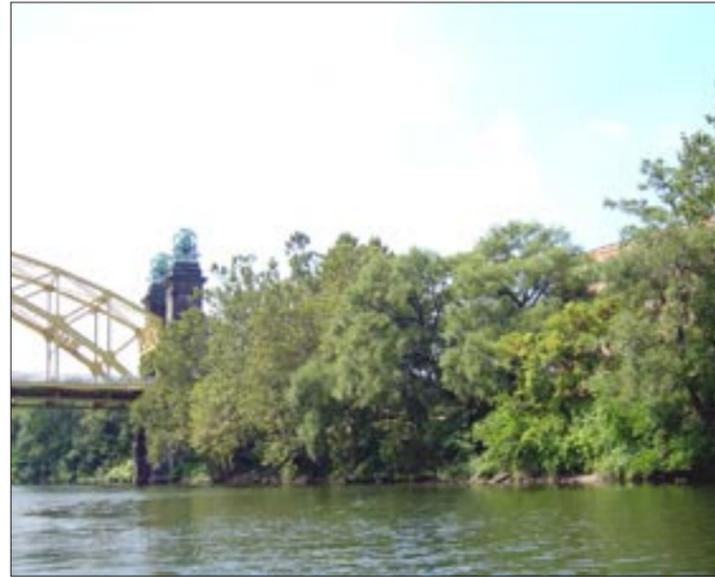
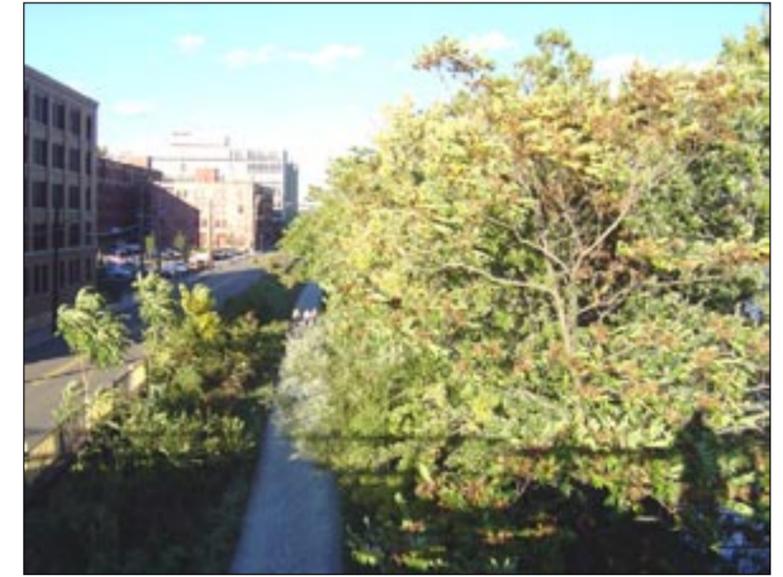
Photos show existing conditions at Heinz Lofts - near continuous layer of canopy trees

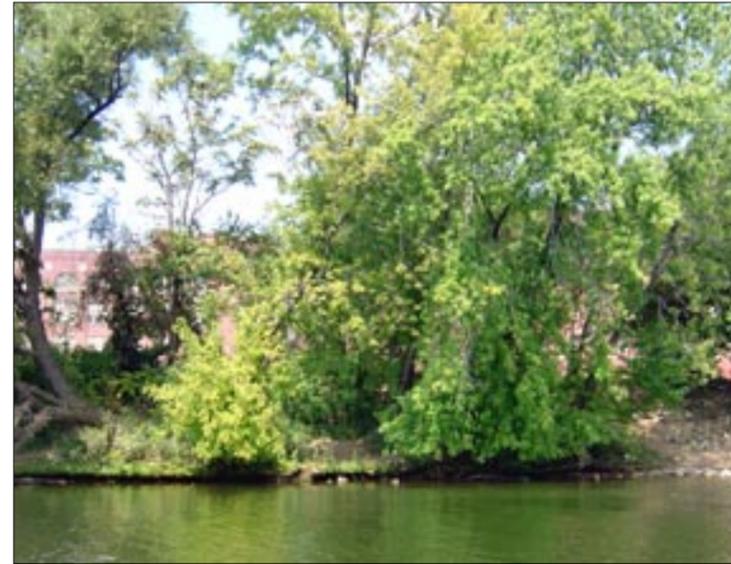
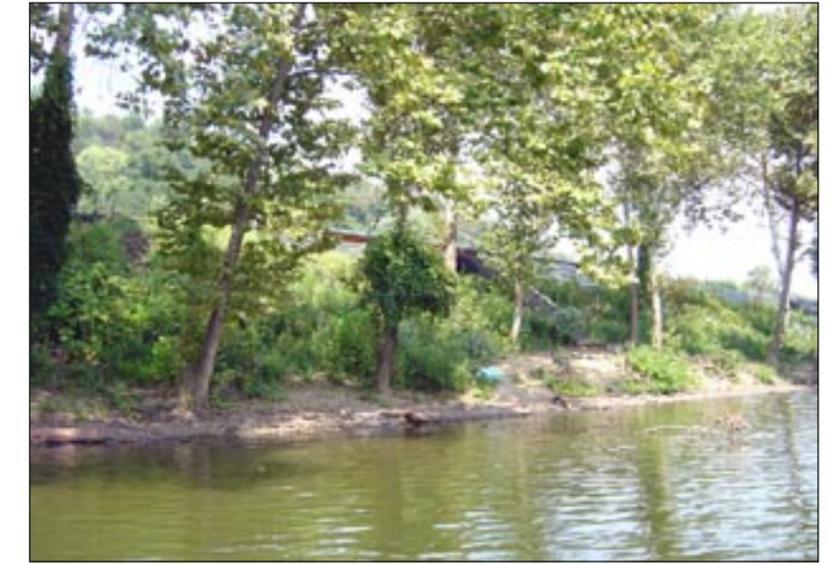
Photos show Millvale Park bank edge — some trees were cleared several years ago, opening up a window for spread of invasive vegetation

- Inventory site conditions, noting locations of canopy trees
- Record conditions on plan and in database
- Remove invasive plants, working with small areas first
- Stabilize toe of slope at Millvale Park with fascines, rock and live stakes (the latter where fishing access is not desired)
- Seed slope with woodland grasses and install geotextile where needed for protection
- Plant upland areas with canopy trees

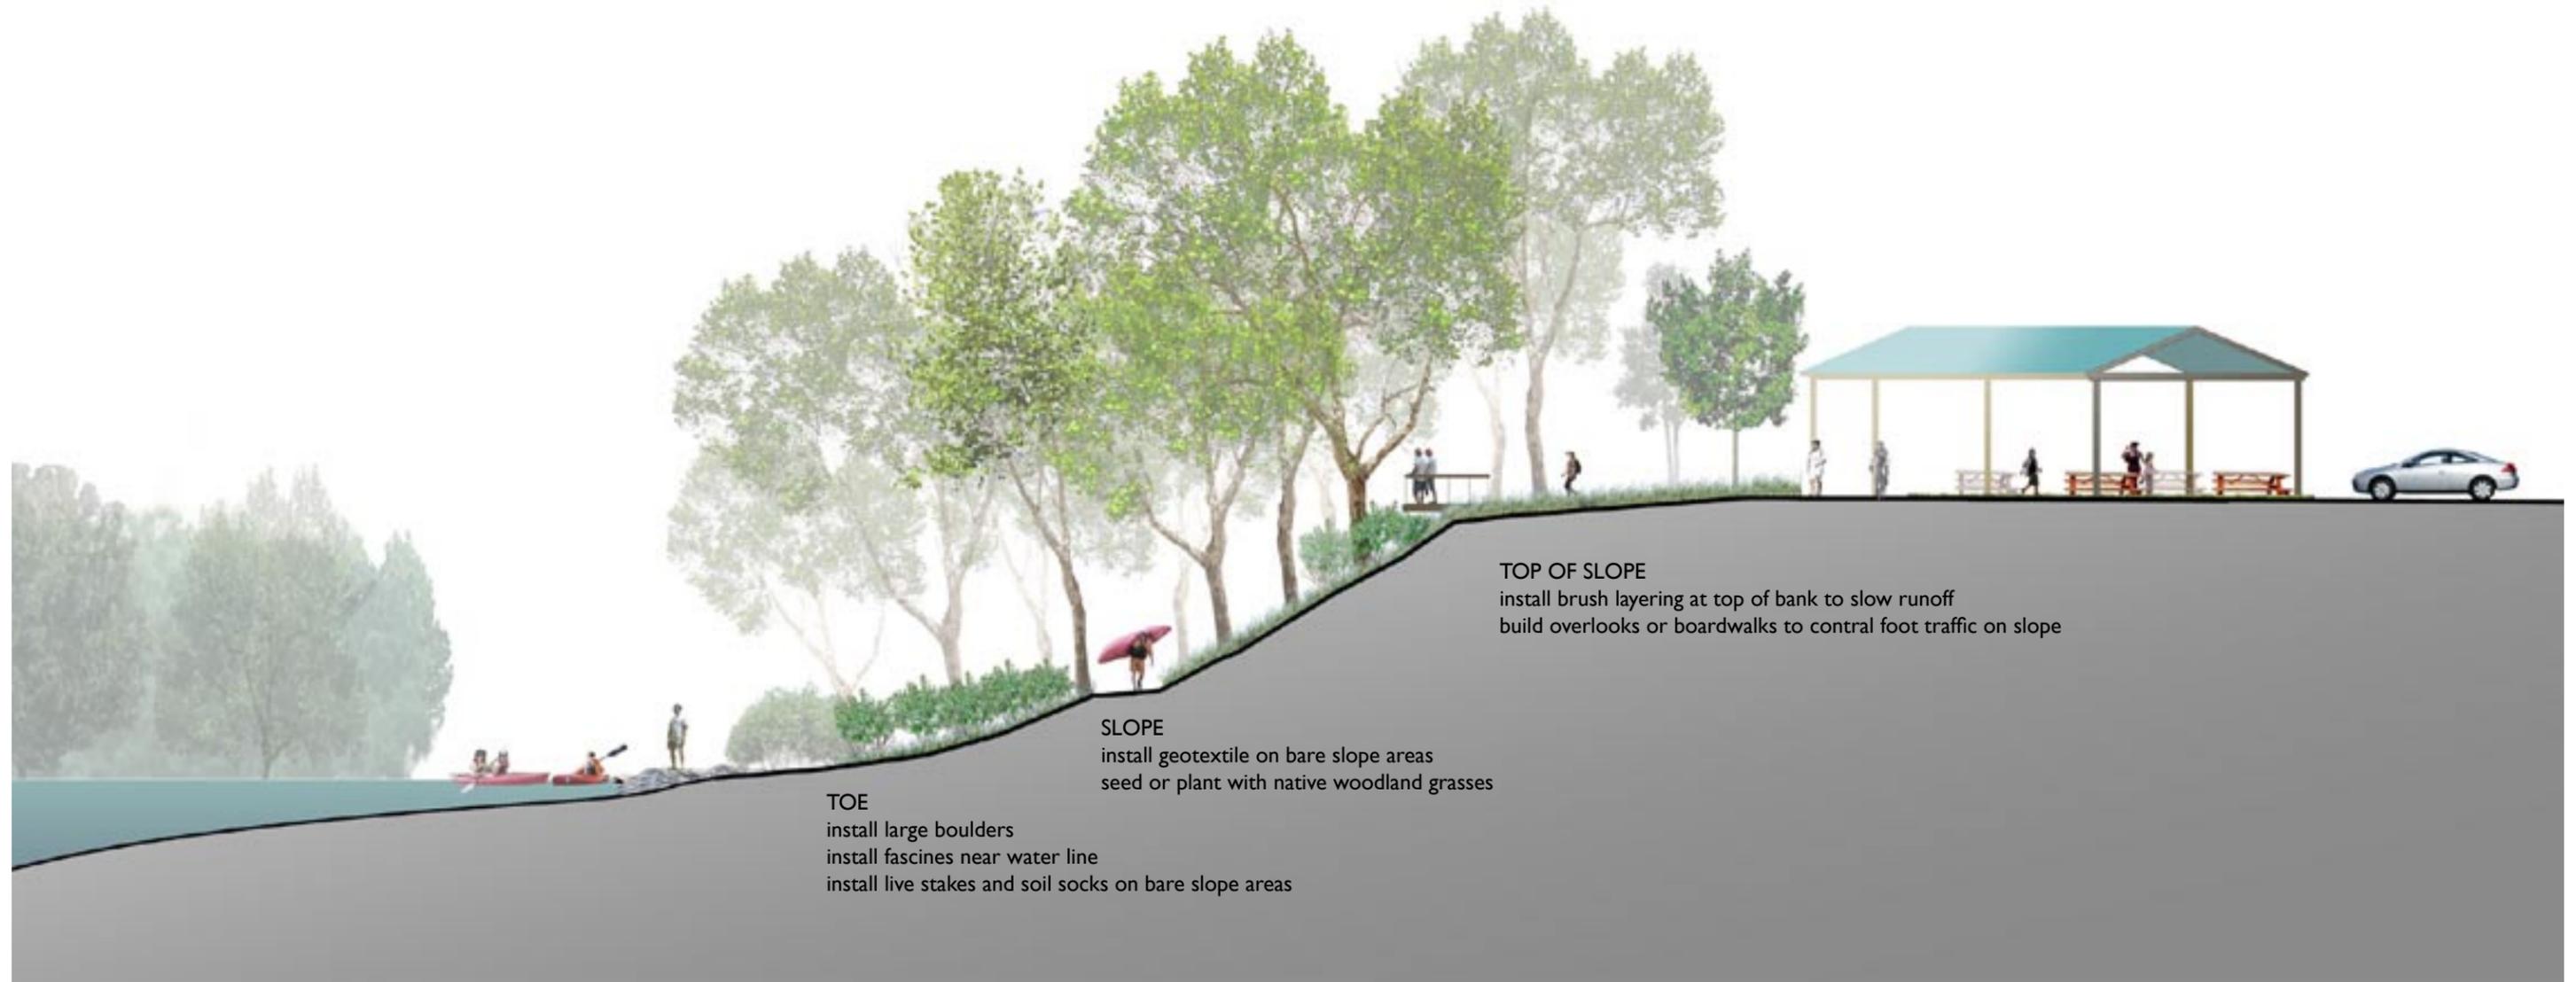
WOODLAND is proposed cover type
VIEWS to river maintained by use of grasses on slope
OVERLOOKS in places that may be threatened by trampling
TRAIL at midslope provides access to river for boating

FIGURE 10. Illustrative Section at Allegheny River / Millvale Park

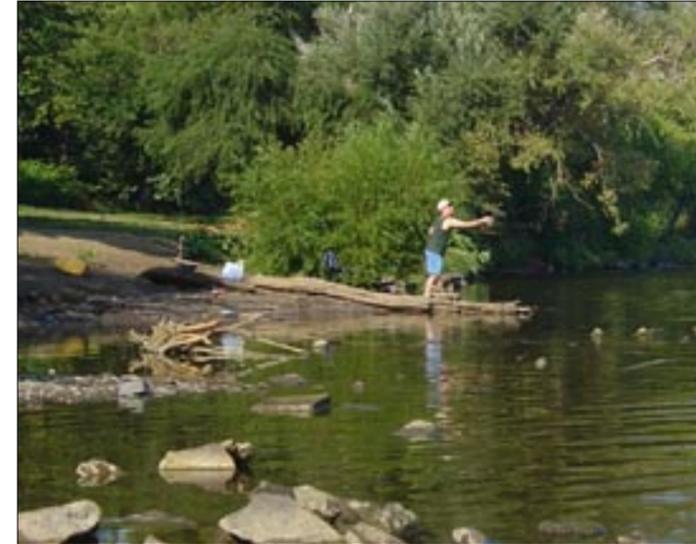
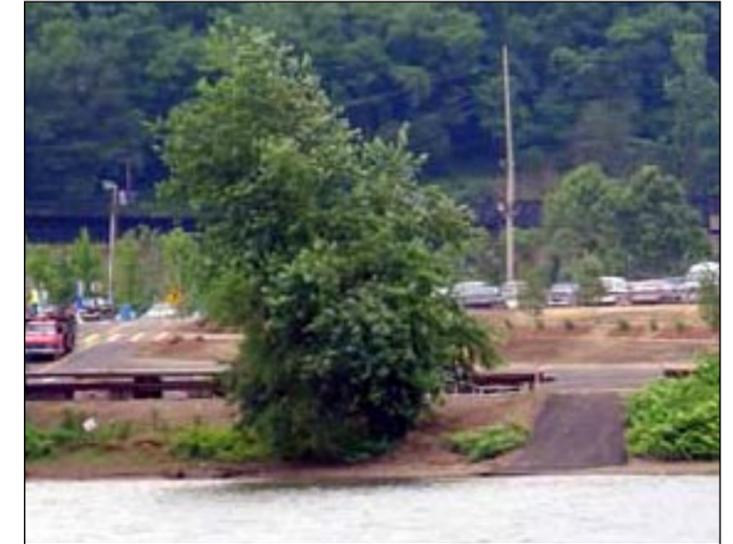
Southside Park and Homestead Works are indicative of shallow banks with good river access. Shallower banks tend to be trampled.

- Inventory site conditions, paying particular attention to extent of invasive species and noting native plants that are thriving, as well as their locations above waterline
- Record conditions in database
- Choose initial areas for management based on extent of canopy from canopy trees
- Install boulders and live stakes at toe of slope
- Remove invasive plants, working with small areas and gradually extending these efforts
- Install soil socks, brush layering and plants in areas of bare soil
- Plant additional canopy trees in upland areas and along Heritage Trail, according to plant schedule
- Record management activities in database

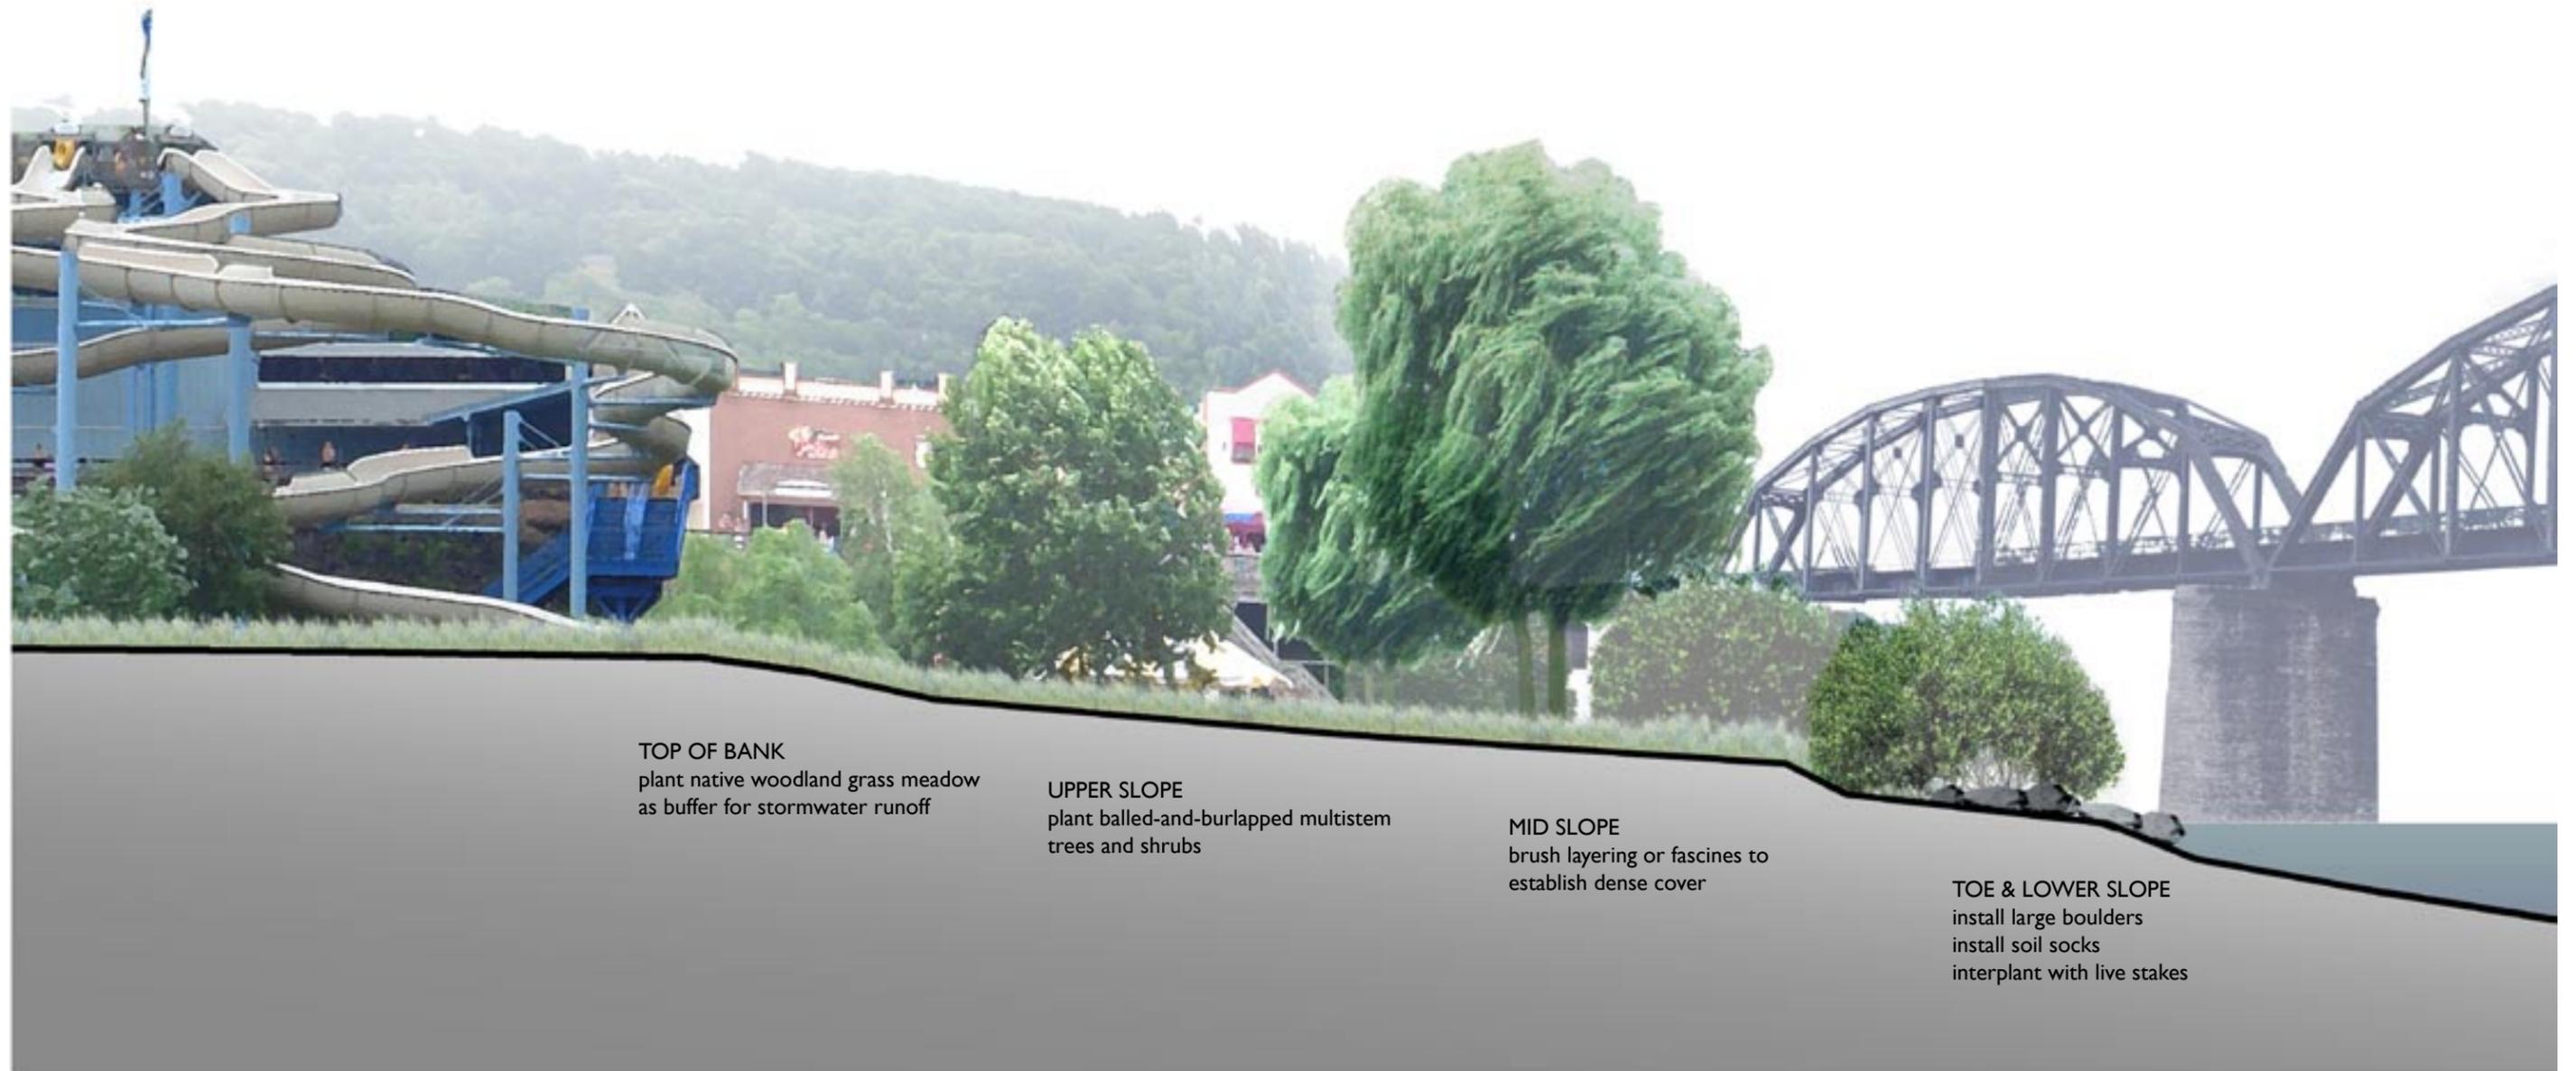
ACCESS for fishing and river viewing is important - accommodate with rock steps or boardwalks

FIGURE 12. Illustrative Section for Monongahela River edge at Homestead Works / Sandcastle

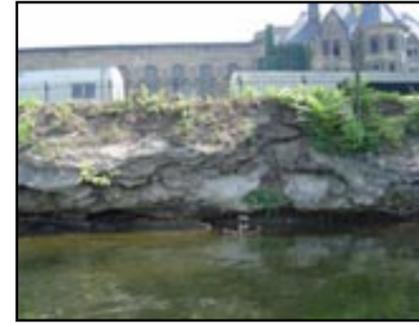
- I.1 North edge of Ohio below Western Penitentiary has near vertical slopes of slag substrate. Restoration on this steep slope will require regrading and a structural confinement system to hold soil, native grasses and wildflowers. The regraded slope will position the North Shore Trail fifteen feet further toward the prison.
- I.2 North edge of Brunot Island has little continuous canopy due to flooding damage and development. Japanese knotweed is rampant. Restoration direction is replacement of knotweed with canopy trees, but disturbance frequency makes this a challenging site.
- I.3 This section is representative of other steep banks along Ohio River that possess significant native canopy vegetation. These can be planted using live stakes and soil containment systems on banks.

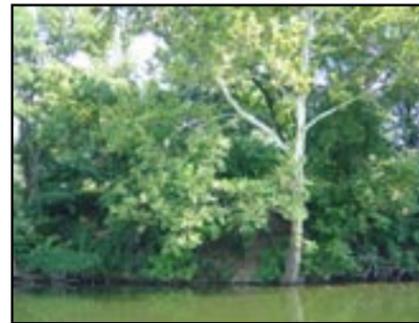
- I.4 South bank of Brunot Island possesses native riparian edge in several places, with canopy of sycamore and willow. Restoration direction is to reinforce forest with native understory trees and shrubs.
- I.5 Sections of Ohio River banks below rail corridor have no access for management at present.
- I.6 Sawmill Run outfall below West End Bridge is an example of a very large CSO – combined sewer outfall – that carries nutrient loaded water to the rivers in wet weather events. CSOs are a long term problem now being addressed by Three Rivers Wet Weather, among others. (www.3riverswetweather.org/)

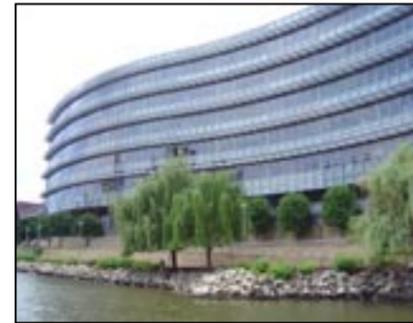
- 2.4 Private developments should follow the lead of Three Rivers Park and plant a border of canopy trees across the bank edge.
- 2.5 Existing parks and planted areas accessible to the public require constant management attention to defray vandalism and replace damaged trees.

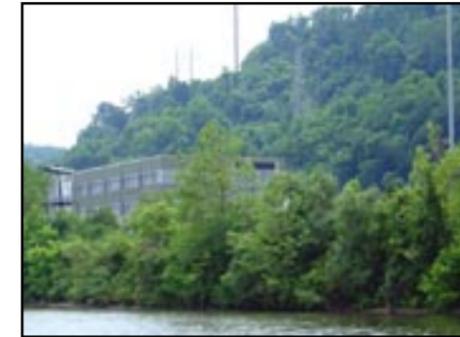
- 4.4 Fairly continuous seawall exists to protect the rail corridor – at present, there is little development at the river edge. The sports facilities could develop a tie-in with river events; if so, this would suggest an opportunity for increased management.
- 4.5 Submerged barges along the Monongahela are nearly obscured by volunteer riparian trees and shrubs, suggesting an interesting adaptation for management and restoration.
- 4.6 Sediment deltas such as this one at Streets Run will eventually become colonized by young Poplars and Sycamores; these can be harvested for river edge restoration before they get carried away by floods.

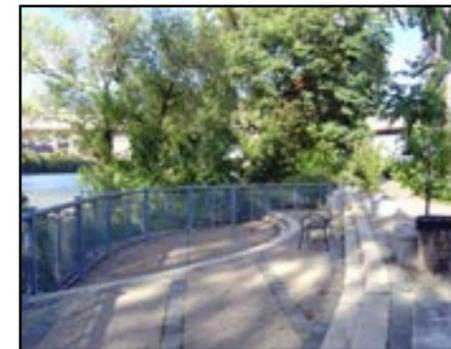
- 6.4 Sections of the Strip District Trail are well cared for – this overlook could be repeated in a number of places along the bank.
- 6.5 The Trail ends before the Cork Factory, where the bank was damaged by storms. Terracing will be needed to establish a basis for new sycamores.
- 6.6 The Three Rivers Trail is incomplete between the 16th Street Bridge end and 23rd Street (at pilings). Once completed, this link will require new canopy vegetation and coordinated management to maintain the same quality as the North Shore Trail.

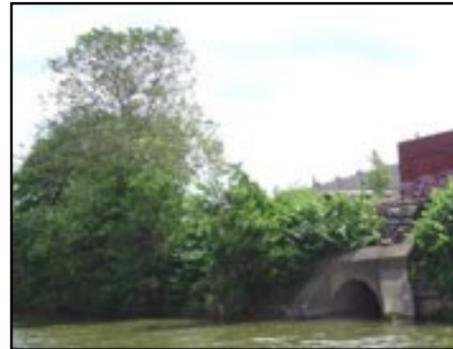
- 7.4 Lower Lawrenceville has an active civic group who could be mobilized to manage this stretch of river corridor. The bank has been cleared along the top, perhaps due to adjacent industrial use and parking; canopy tree planting should begin immediately along the Lawrenceville Trail between 36th and 46th streets.
- 7.5 Banks such as this one that are cleared for access often invite dumping. The bare slopes to either side of the stairway should be stabilized with soil containment geotextiles and replanted with sycamore trees and silver maples.

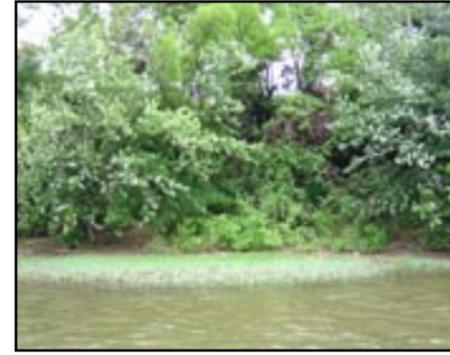
- 8.1 An example of the water-willow/smartweed riverbed community, a native plant community that becomes established where depositional sediment develops along vegetated banks, or among rocks in the river.
- 8.2 Six Mile Island represents a terrific opportunity for conservation and ecological management. In the interim, it has become a deforested campsite with compacted, degraded banks.

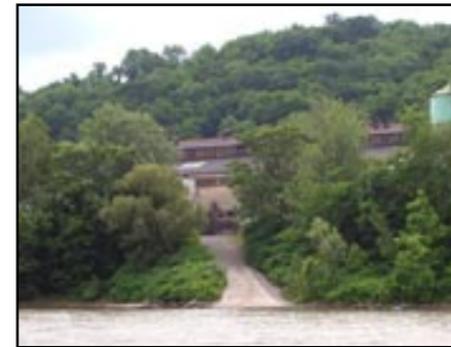
- 8.3 This river access is in better condition than many. Of significance is the fact that the banks remain well vegetated.
- 8.4 This section of river, above and below the Highland Park-Aspinwall Dam, represents a great opportunity for coordinated restoration and management with the Park.

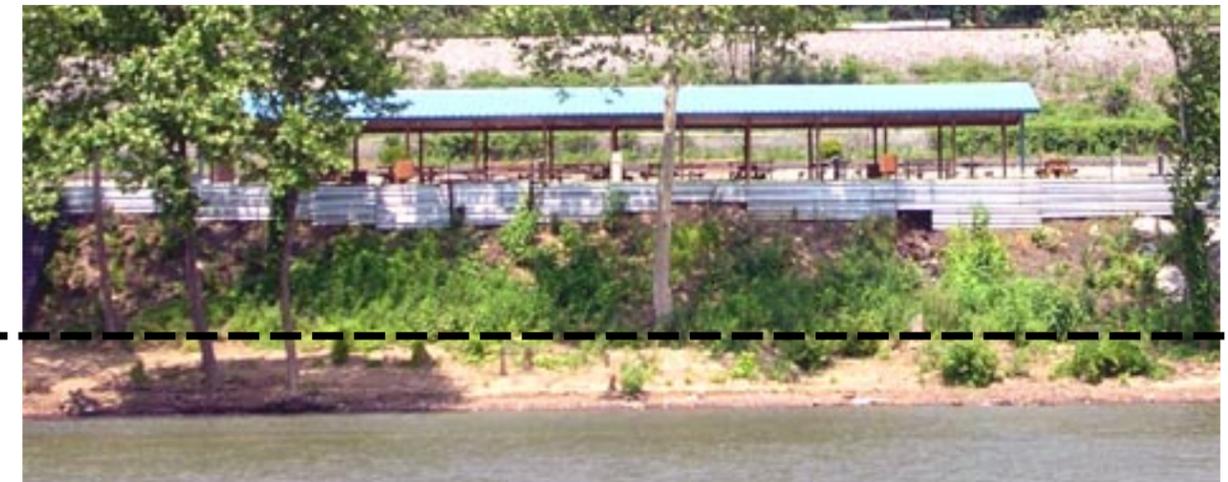
At Millvale Park flood waters have scoured banks below the 712 elevation – shown as dotted line. Bioengineering is needed to establish plants in this zone.

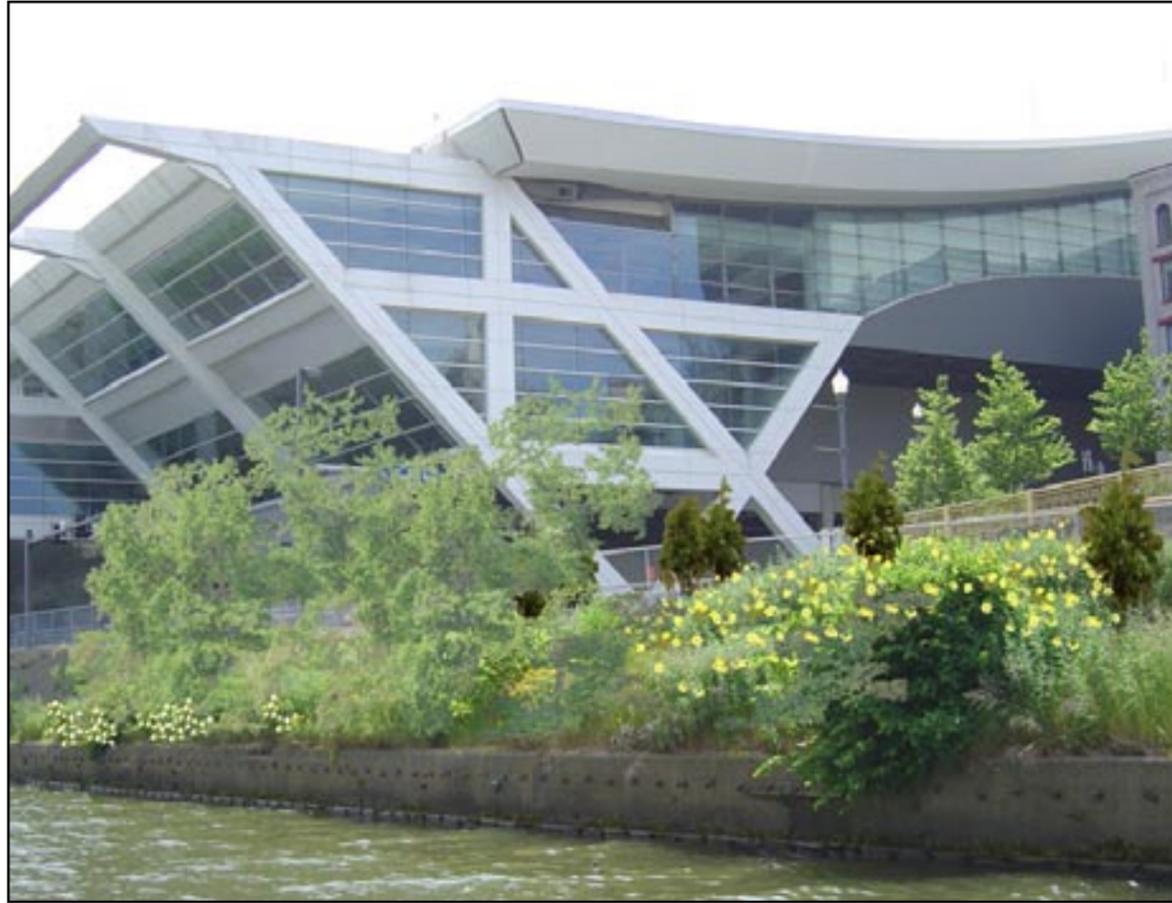
FIGURE 15. Occasionally flooded river edges should be planted with vigorous plants that compete successfully with weeds

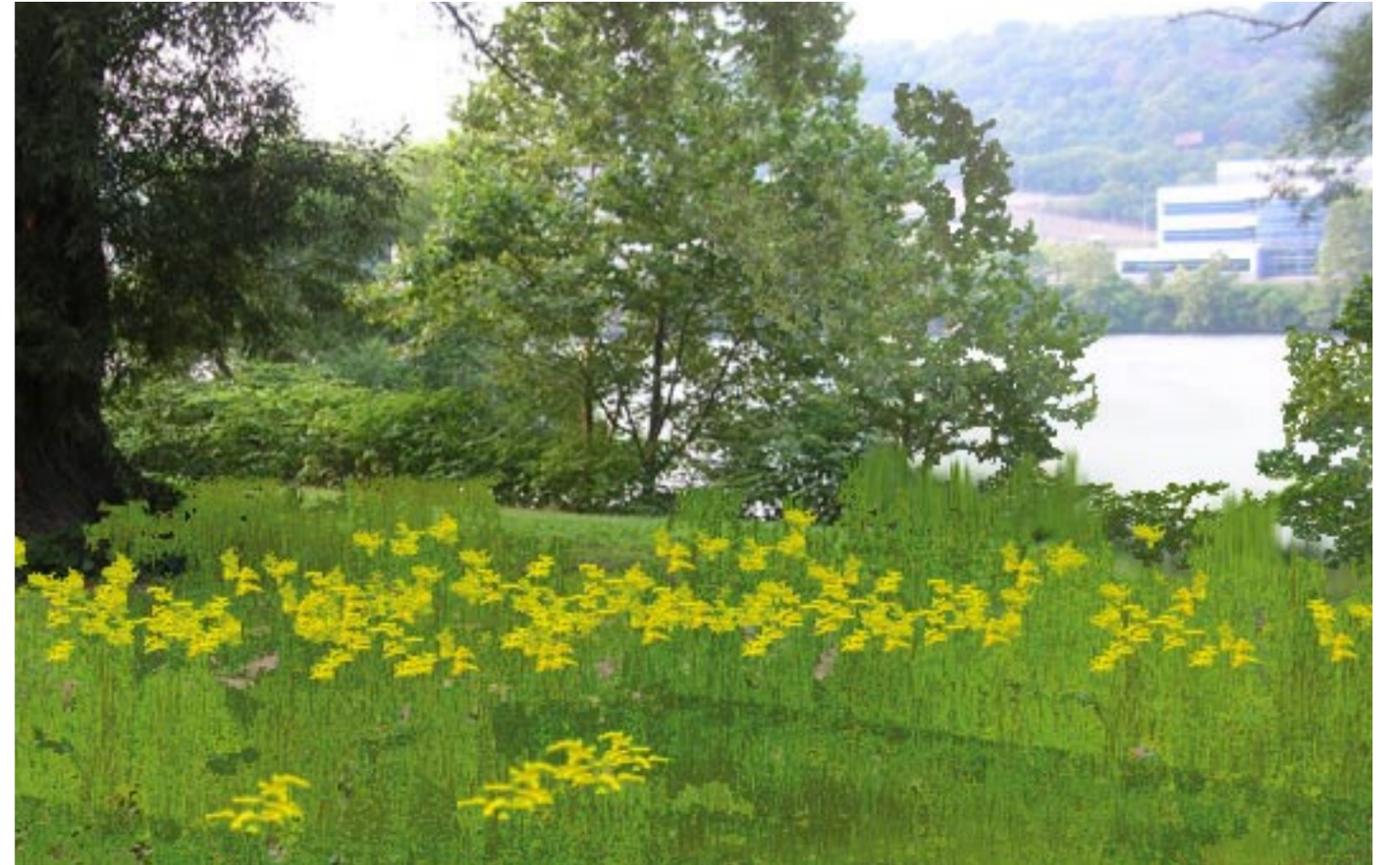
FIGURE 16. Upland meadow buffers planted next to lawn – as illustrated here at Southside Park – can slow runoff to rivers

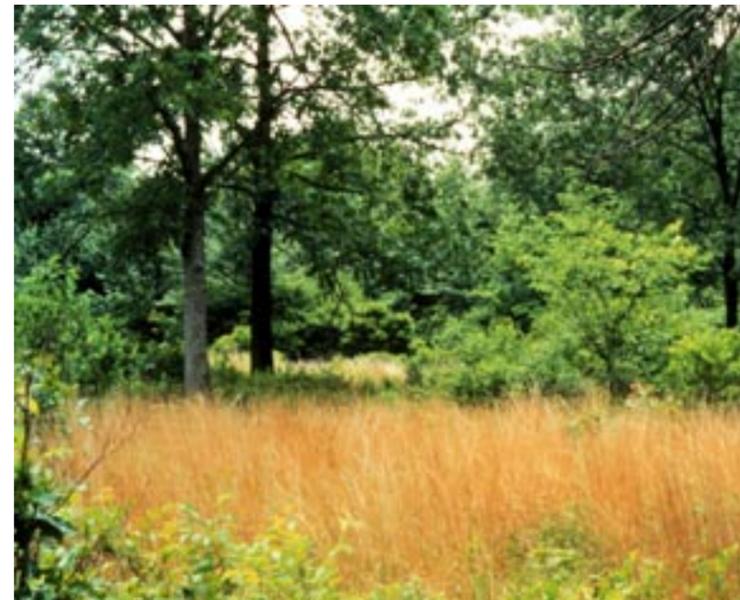
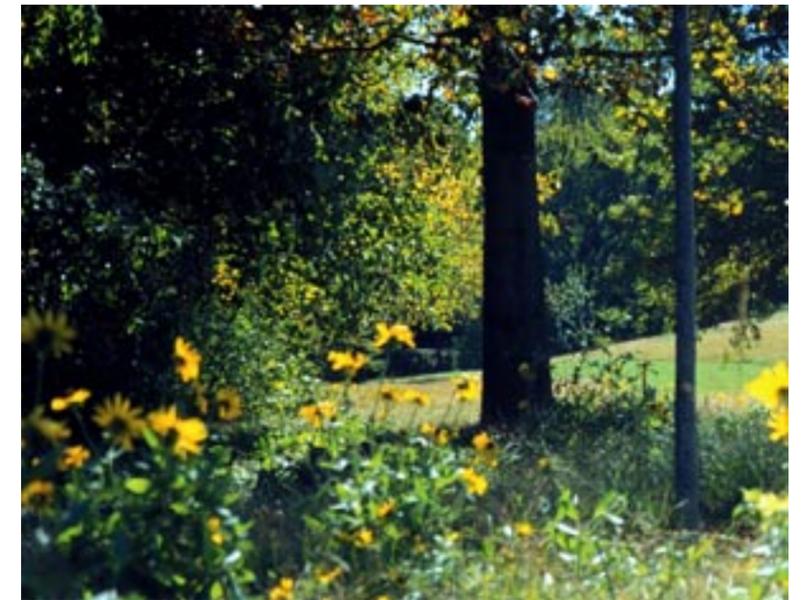
Upland plantings can be managed as informal parkland where adjacent to trails and other recreational uses

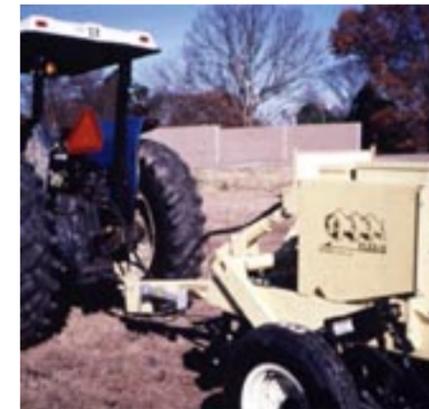
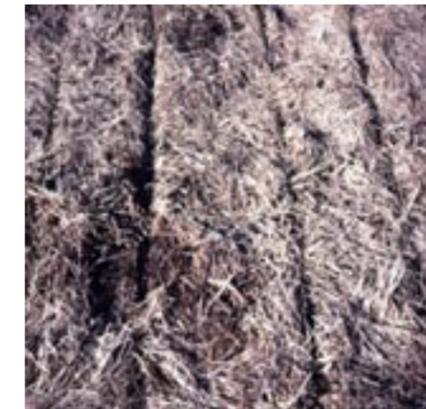
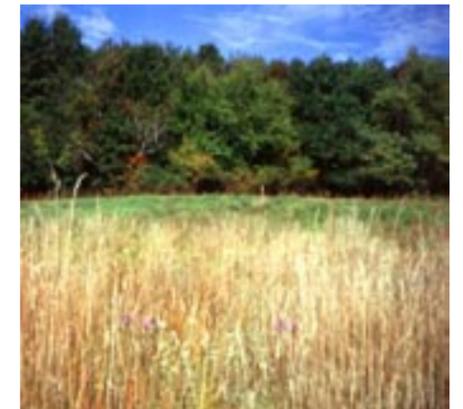
Drill seeding is an effective way to establish a meadow planting
 From left to right: Drill seeder, drill seeded pattern on prepared site, seeded meadow 2 years after seeding

FIGURE 17. Typical Planting Detail – emphasizes care of root mass

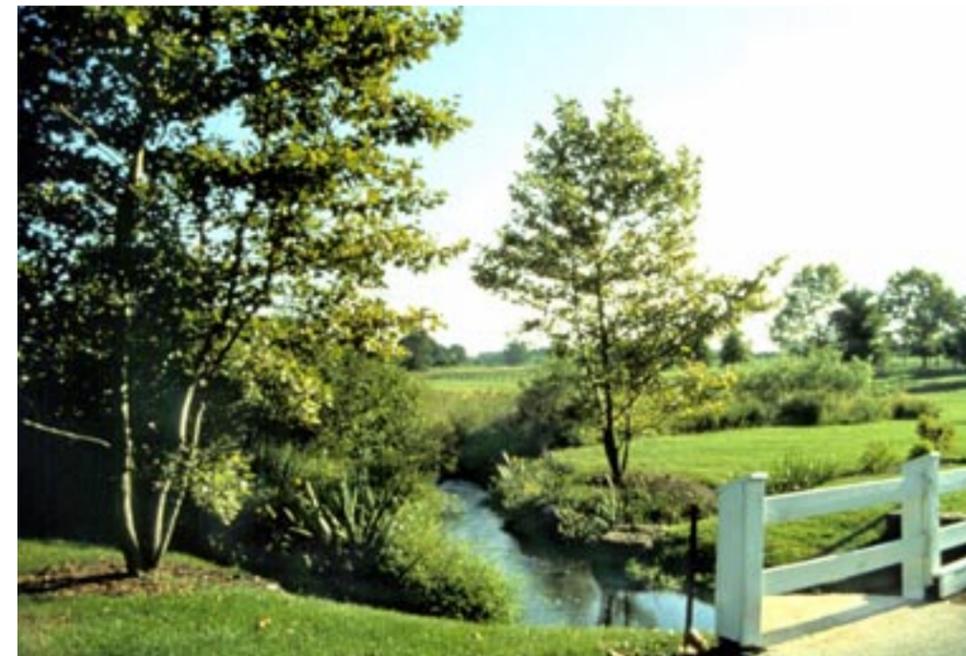
Photograph of restored stream on corporate campus planted with live willow stakes inserted into fiberschines. The fiberschines not visible.

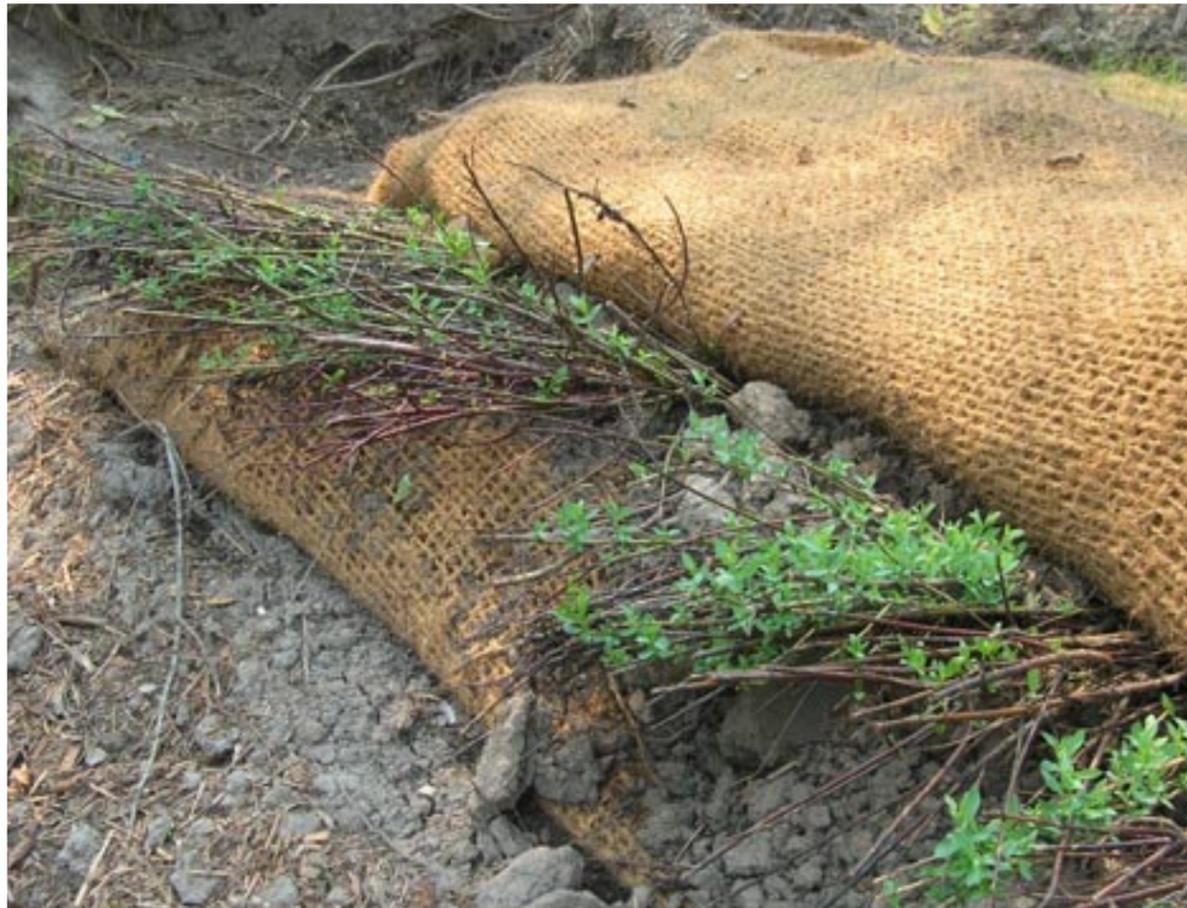
FIGURE 19. Diagram of brushlayer construction: The Practical Streambank Bioengineering Guide

These are vertical bundles parallel to the shoreline buried in one or more trenches at the top of the bank. Brush trenches or hedges are good for filtering runoff at top of bank and top of bank stabilization.

Photo of Nine Mile Run stream restoration courtesy of Nine Mile Run Watershed Association

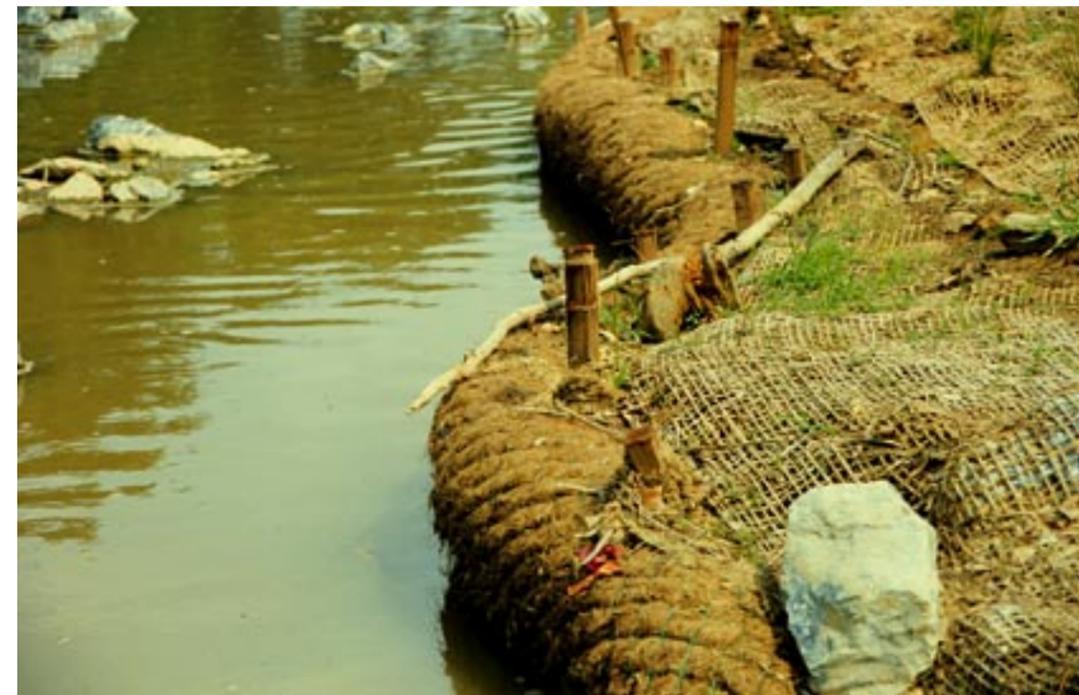
Photo of fiber roll, a commercially produced stream stabilization product with a similar concept to fascines. Fiber rolls are usually made of rolled coconut fiber secured with webbing. They may be shipped with wetland plugs inserted into the rolls.

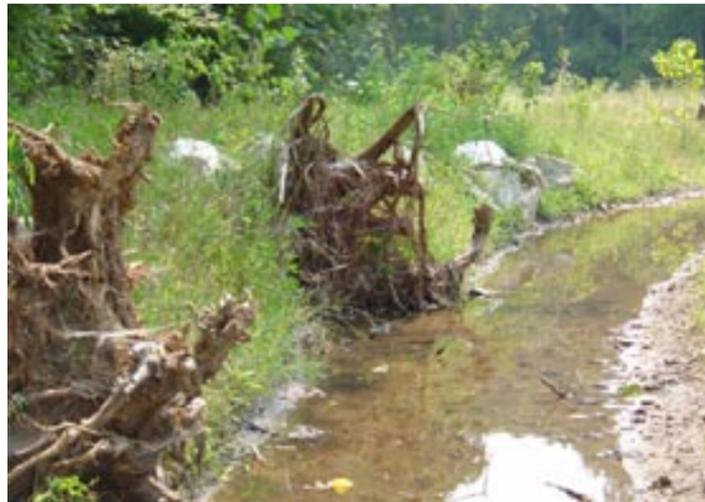
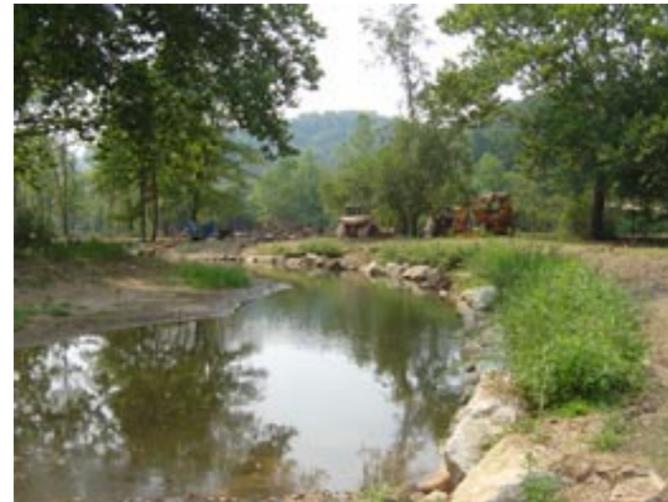
Photos of Nine Mile Run restoration showing root wads and natural boulder stabilization
