THREE RIVERS PARK LANDSCAPE MANAGEMENT GUIDELINES

DECEMBER 2006

ANDROPOGON ASSOCIATES LTD.
CIVIL AND ENVIRONMENTAL CONSULTANTS, INC.
RIVERLIFE TASK FORCE

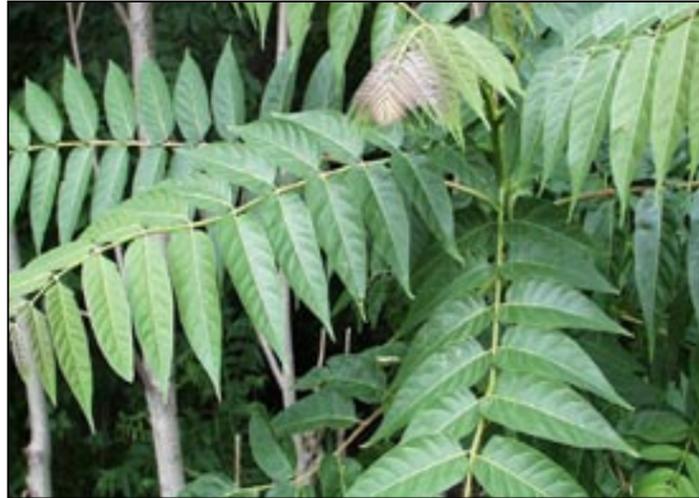
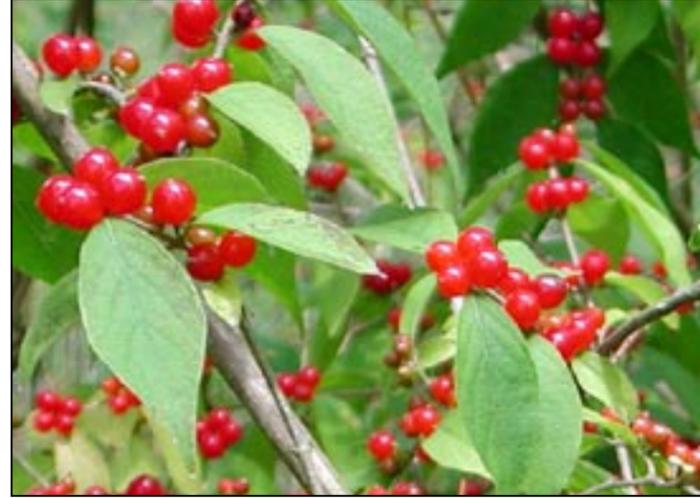
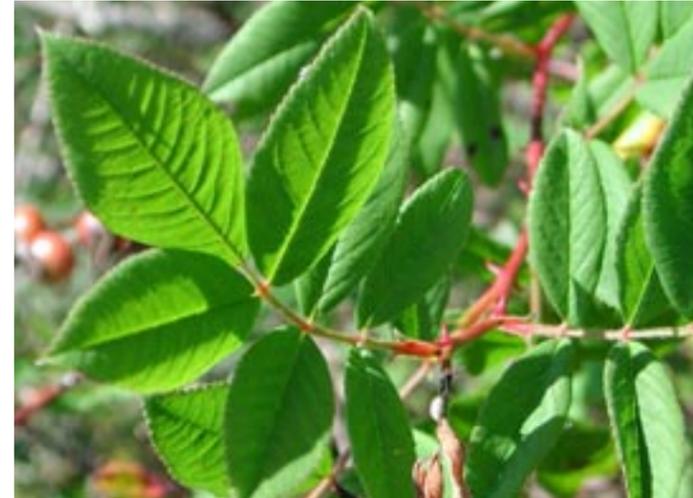
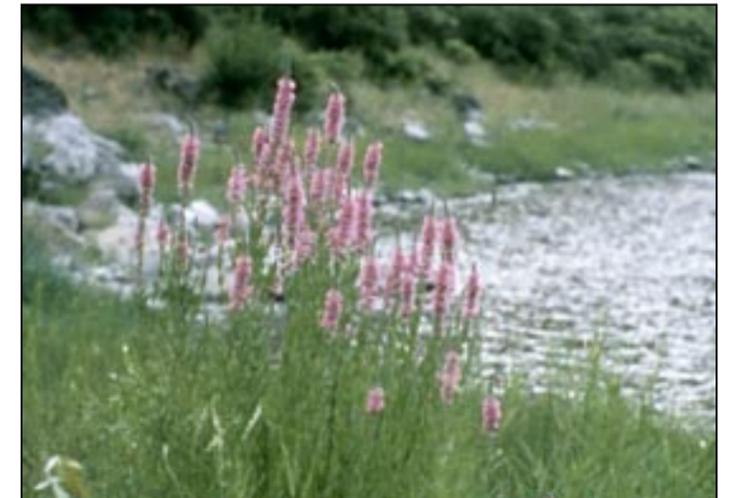
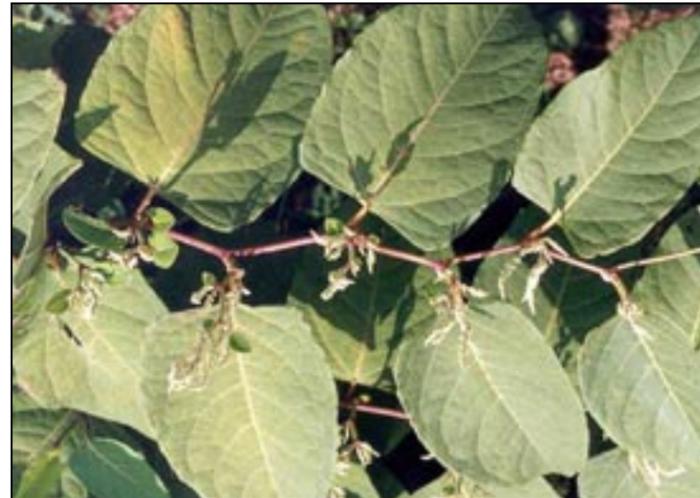
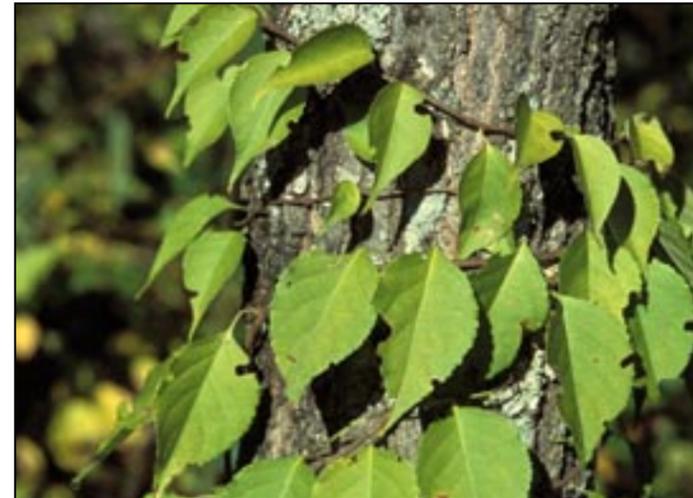
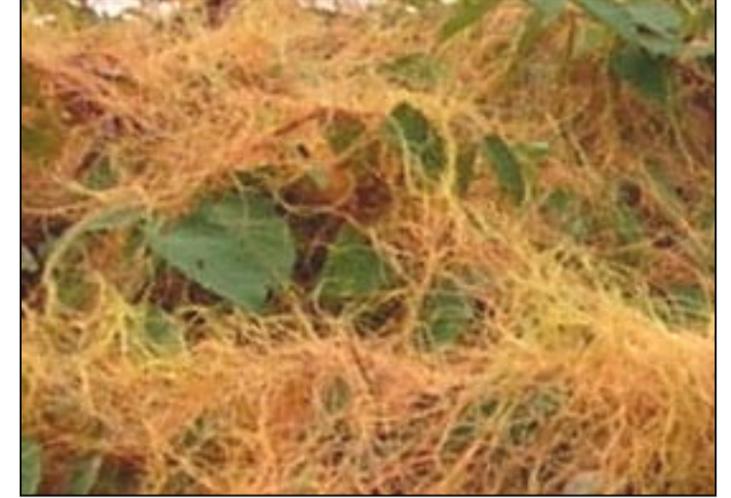
All photos except Japanese dodder courtesy of USDA Forest Service, Invasive Plants of the Eastern United States CD-ROM USDA APHIS PPQ Archives (www.invasive.org/eastern)
 Upper row: Tree of heaven, Amur honeysuckle, Multiflora rose, Purple loosestrife
 Lower row: Japanese knotweed, Oriental bittersweet, Japanese dodder (photographed at Southside Park August 2005)

Manual hand pulling: Best done following rain, this is still the most effective means for removing herbaceous weeds or small seedlings of woody plants. This method is recommended for young *Ailanthus* seedlings – care must be taken to remove the root, since *Ailanthus* can sprout from root suckers. Tools:

Mulching: A thin layer of organic material can prevent less invasive seedlings from sprouting. Wood mulch is recommended for woody plant material. Straw mulch (not hay – this will bring weed seeds) is recommended for meadow areas. Heavy black plastic – 4 mil or greater – can be staked over oriental bittersweet or Japanese knotweed, effectively cooking the plants.

Burning: A valid method in more rural areas because it promotes mineral-based soil and greatly assists with non-native weed suppression. Burning is the most effective method for eliminating Japanese dodder, since this plant loses its contact with the ground once it spreads. Propane torches can be used to spot treat individual plants but should be used with extreme caution to not cause larger fires. Users should check with local officials for legality of open flame use. Due to the complex nature of the task, it is recommended that burning be carried out by professionals.

Biological controls: Most invasive species do not have proven, commercially available biological control agents. Cornell University mass produces beetles for control of purple loosestrife, a very effective measure if the beetles are released in sufficient quantity.

Herbicides: Herbicides must be applied by a licensed applicator and always used with care to avoid killing desirable natives. Use the least persistent pesticide available to accomplish the job, and exercise caution around water bodies due to the susceptible nature of aquatic organisms. Herbicides are the most effective means of destroying tree of heaven, multiflora rose and oriental bittersweet.

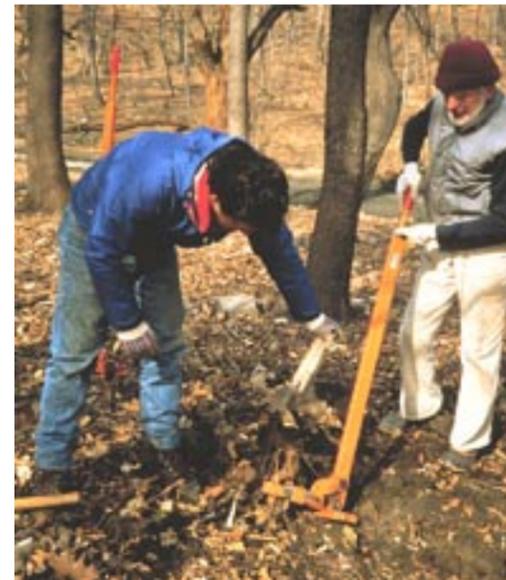
Using a weed wrench to remove Norway Maple seedlings

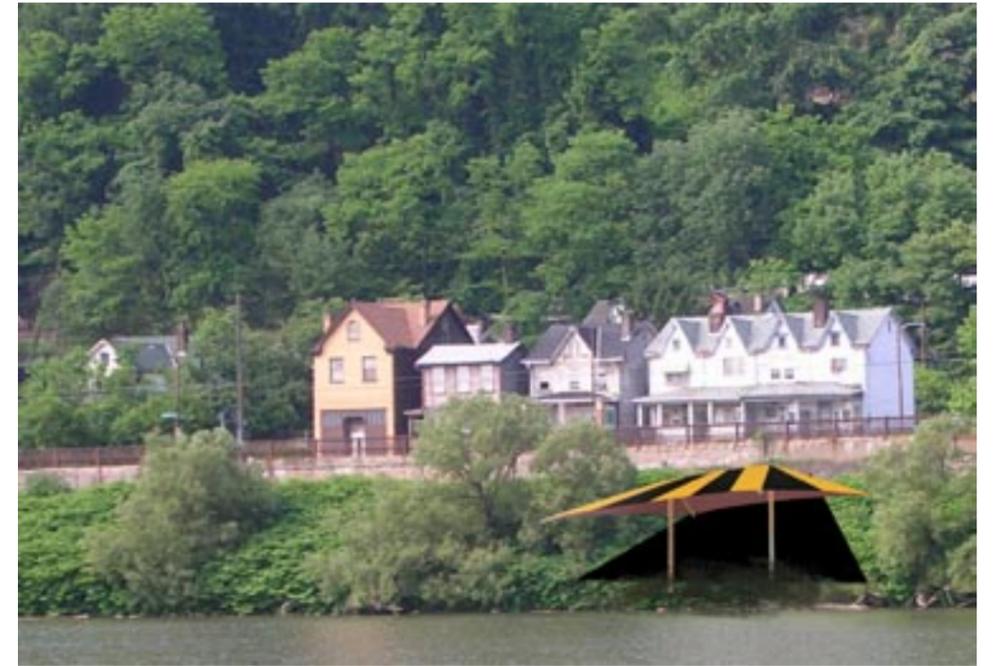
FIGURES 27 & 28. Illustrations show black and gold canopies identifying japanese knotweed infestations being treated with black plastic mulch shading. Digital images by Andropogon.

Japanese Knotweed is not likely to invade forest habitats because low light conditions do not favor its growth. Reestablishing forest canopy in habitats along the rivers will help in controlling the spread of the species. The effect shading has on growth provides an opportunity to educate the public on the pervasive nature of the species. Bright yellow fabric canopies could be erected in key visible areas (parks, shorelines, islands) to cover small clumps of Japanese Knotweed. These canopies could be used to experiment with shading as a control method, but more importantly could incorporate interpretive signage that addresses the problem and provides the public with information about what they can do as individuals. With a large number of canopies along the Pittsburgh Pool shorelines, this environmental art project could increase public awareness about Japanese knotweed and the other issues that plague our water based ecosystems. Canopies could be moved each year to new locations to increase public exposure and increase the number of clumps of knotweed that receive this shade "treatment."

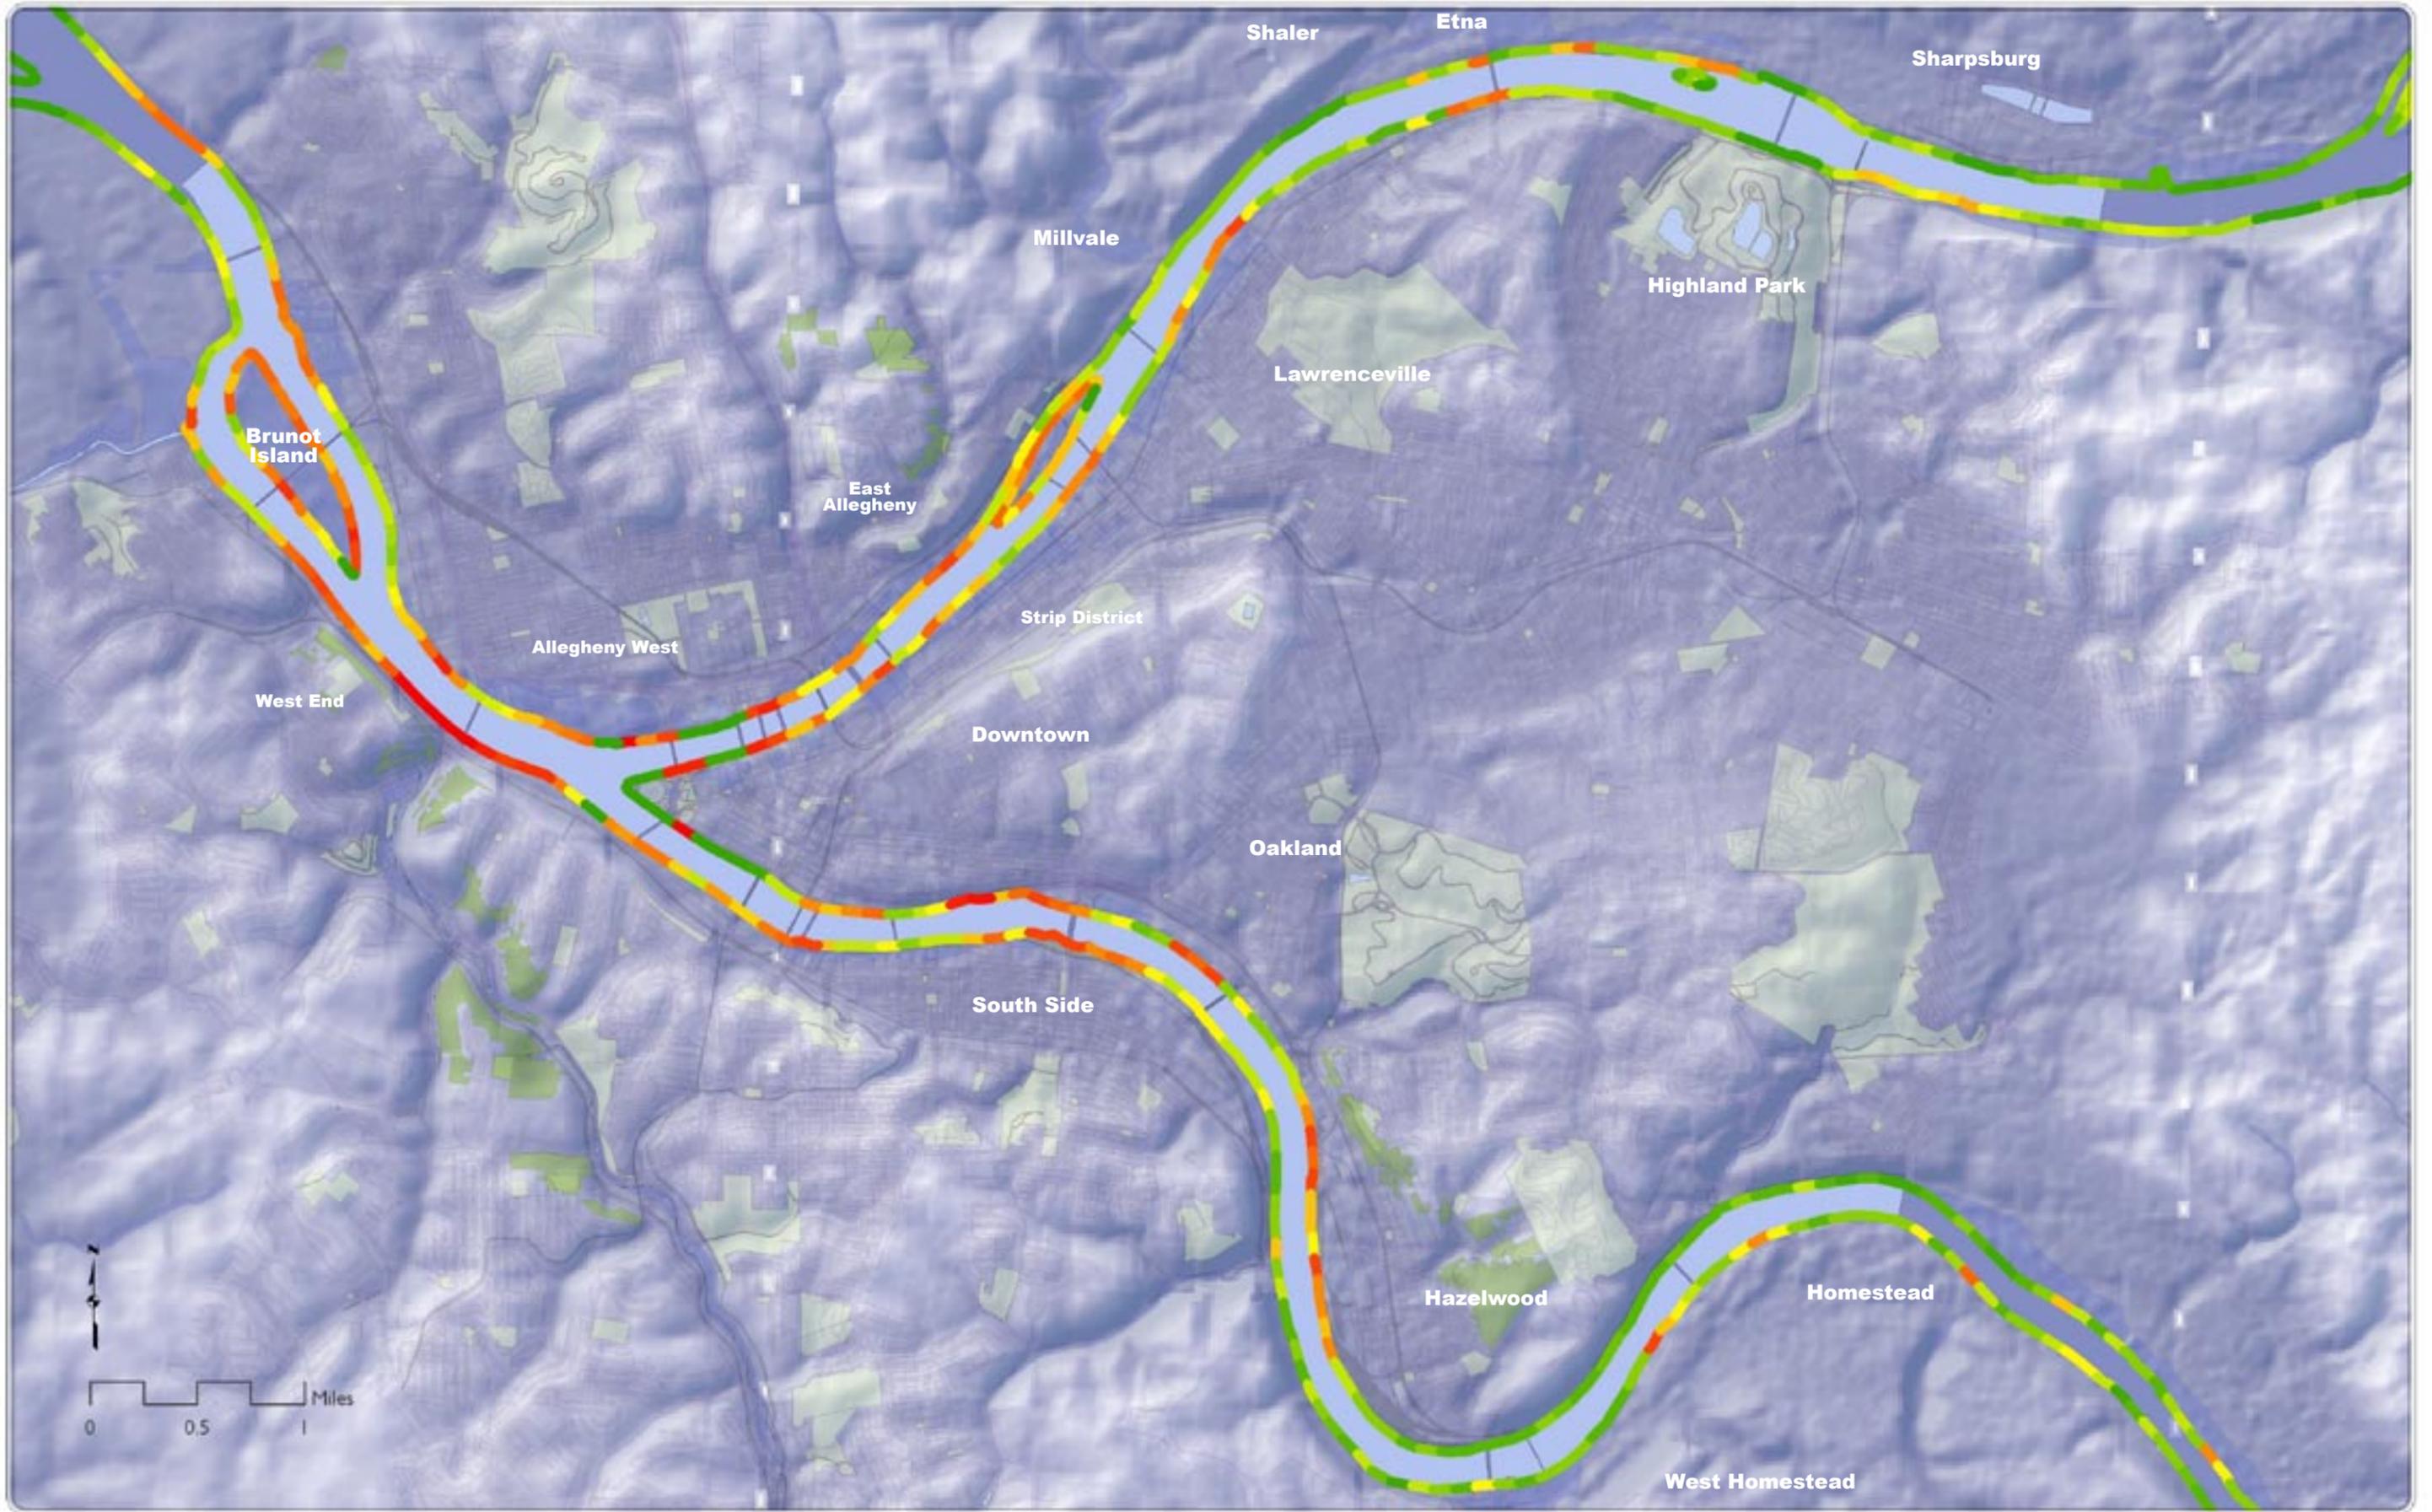
MAP 13 (opposite page). GIS Map of Invasive Species ranks presence of Japanese knotweed on percent basis
